# Chatfield Marina

## Reallocation Impact Assessment Report

### Chatfield State Park - Littleton, CO

February 2011

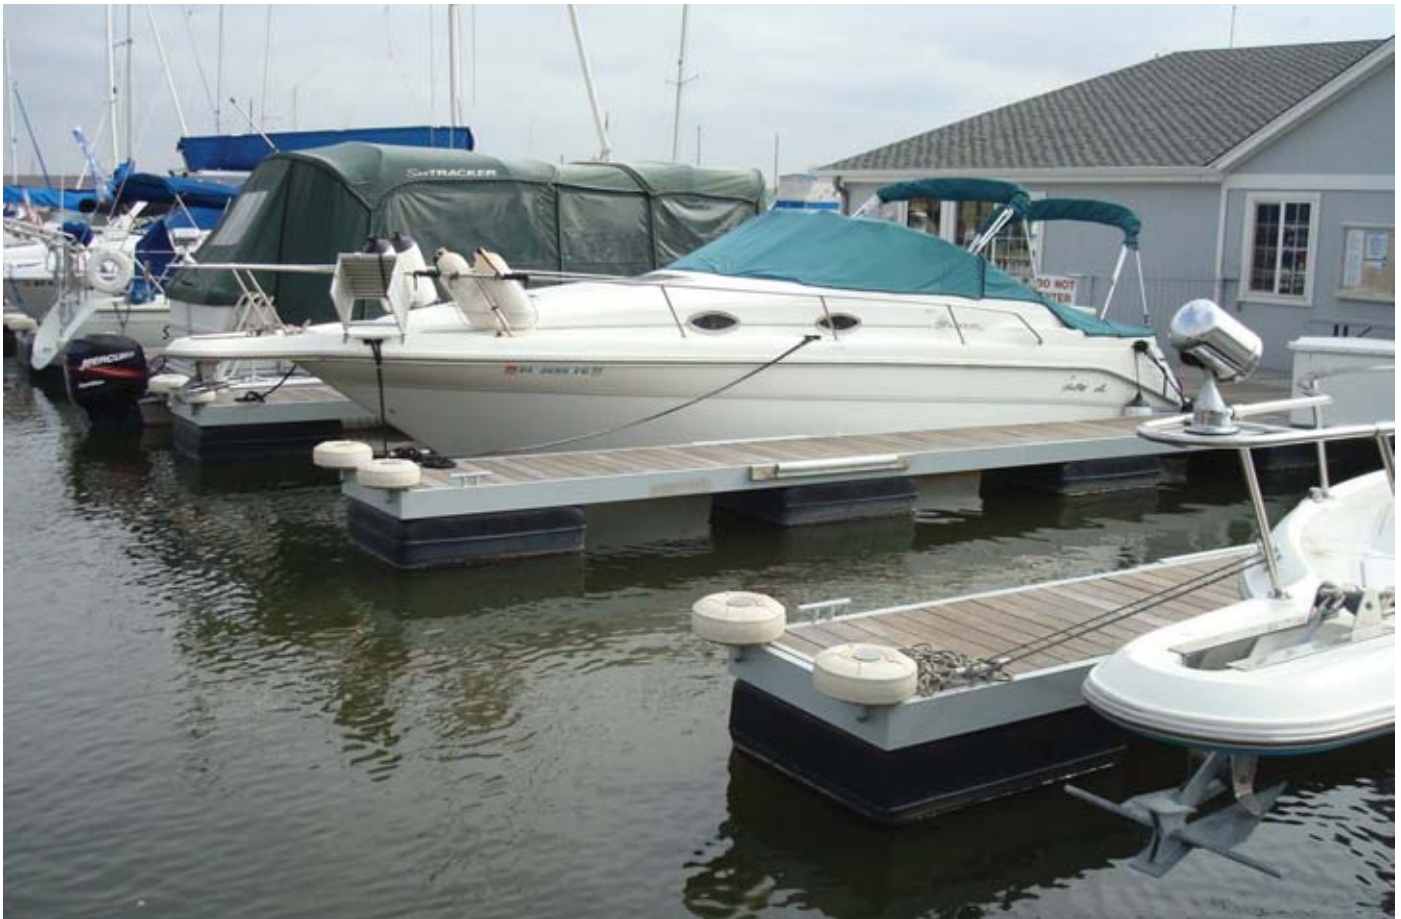
3-2 Floating Docks Side View

The existing floating dock system was built by the operator incrementally over the last 27 years. The dock system consists of welded tube steel frames, polyethylene encased polystyrene floats, and lpe (sustainable Brazilian hardwood) decking. The frames have field welded connections along the mainwalks and hinged connections at finger and secondary platform connections. The shallow nature of the tube frames results in significant flexure (bounce) of the dock system when subject to pedestrian loads. The frames, floats, and decking are all in excellent condition and have been carefully maintained.

The system is more sensitive to wave and wake action than modern factory manufactured systems and requires wave and wake protection along with protection from moving ice.

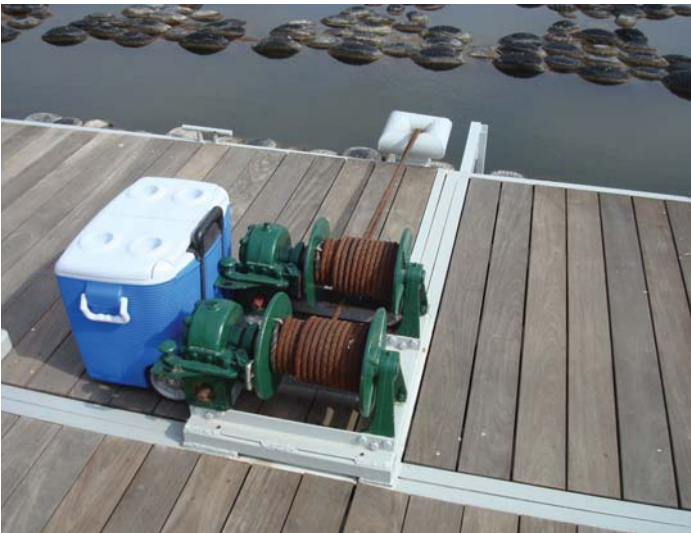
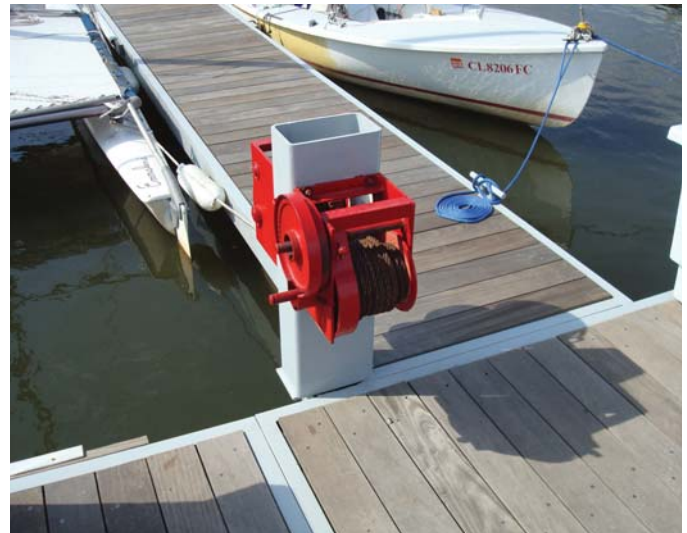
3-4 Cable and Winch Systems

The marina docks and the breakwater are held in place using a cable and winch system. The system is anchored to the bottom of the reservoir with a combination of concrete anchors and helix anchors. The anchors are installed and maintained by the operator using a custom spud barge. The 99 anchor point system requires occasional movement and adjustment by the operator. Discussions with the operator reveal that the anchor system, like the dock system has been incrementally expanded and modified over the years.

The anchor system is limited in its current configuration to the normal range of elevations plus occasional flood elevations to 5,472' +/- . The cables associated with the anchor system at the outboard walkway cross the surface of the decking at some locations which result in a significant tripping hazard. The anchorage system in place today was developed by the operator and represents the current system and conditions. Changes in either will probably require a complete reanalysis of the system to meet the new conditions.

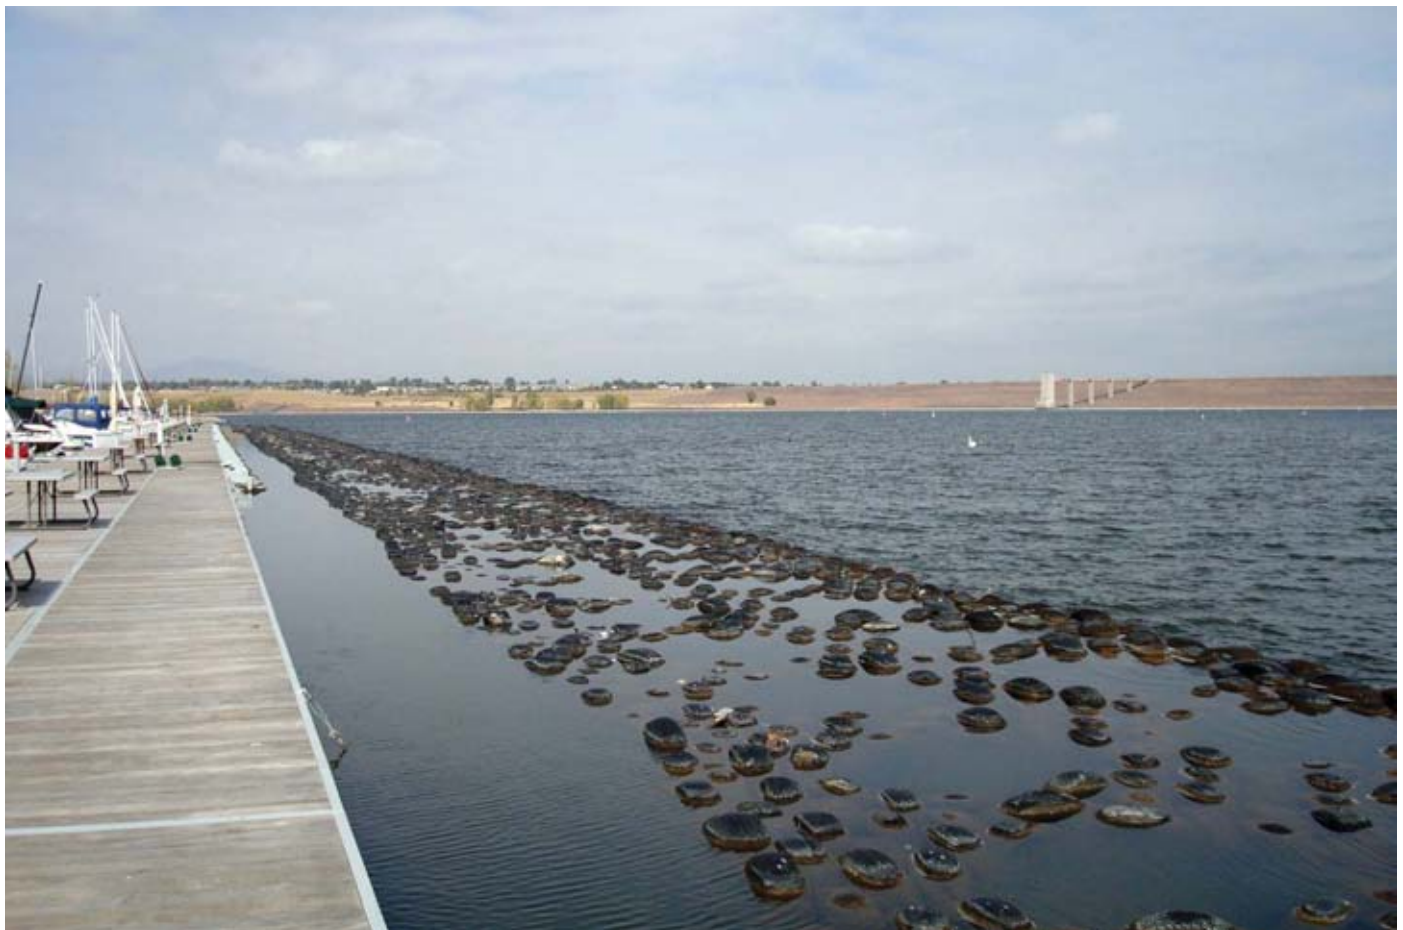
3-5 Floating Tire Breakwater

The north and west edges of the marina are vulnerable to wave and wake action from the main body of the lake. Additionally, spring thaw results in significant ice movement on the lake. The marina operator has installed a floating tire wave attenuator to protect the marina docks along these edges. The two part attenuator has an inner barrier attached to the outer edge of the docks. The outer 18' wide mat of tires is anchored independently of the floating docks and is separated by approximately 6' from the inner system on the north and 2' on the west. The anchorage of the floating breakwater is not adjustable.

The system was popular for marinas in the 1980's as a lower cost alternative to fixed breakwaters or floating concrete structures. Although the system is not very attractive, it has worked very well over the years. Without the protection of the wave attenuator, it is likely that this dock system could experience increased damage from wave and ice impacts.

Additionally, since the current floating tire breakwater anchorage system is not adjustable, this system would not function as intended at the FWSP and would be submerged under flood events. A replacement or major reworking of the breakwater would be expected for the new operating conditions.

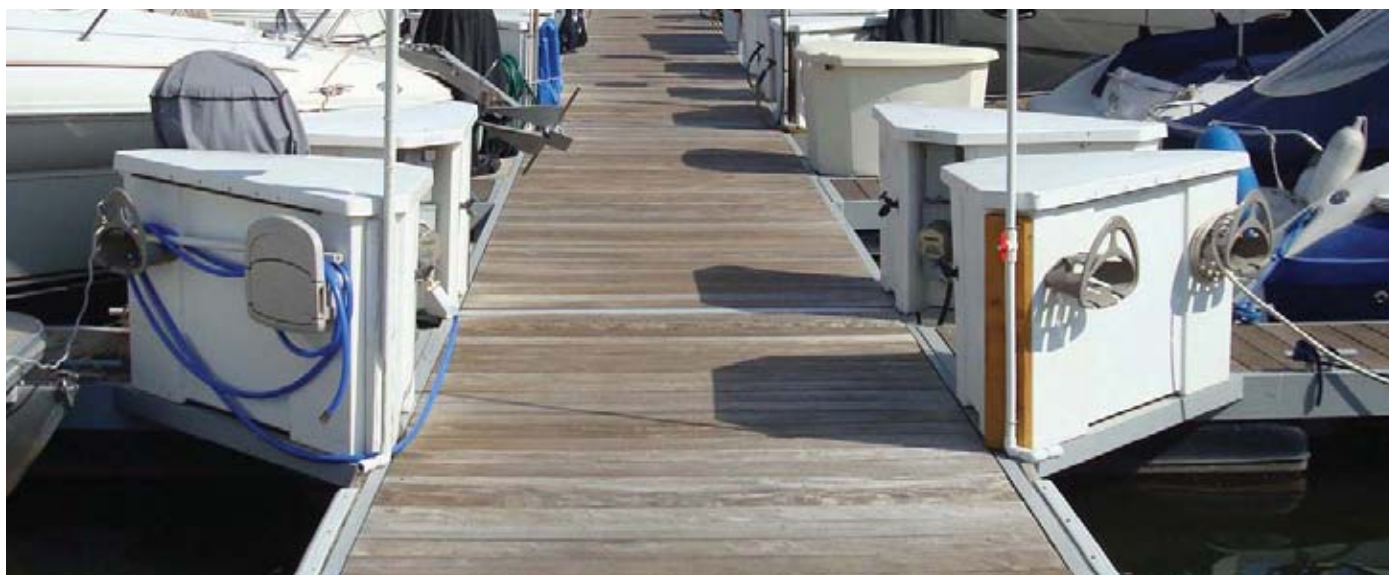
3-6 Dock Utilities

The slips that have power also have potable water supplies. There is no fire protection system in the marina. Fire cabinets and extinguishers are located throughout the marina docks to provide a nominal level of fire abatement capability.

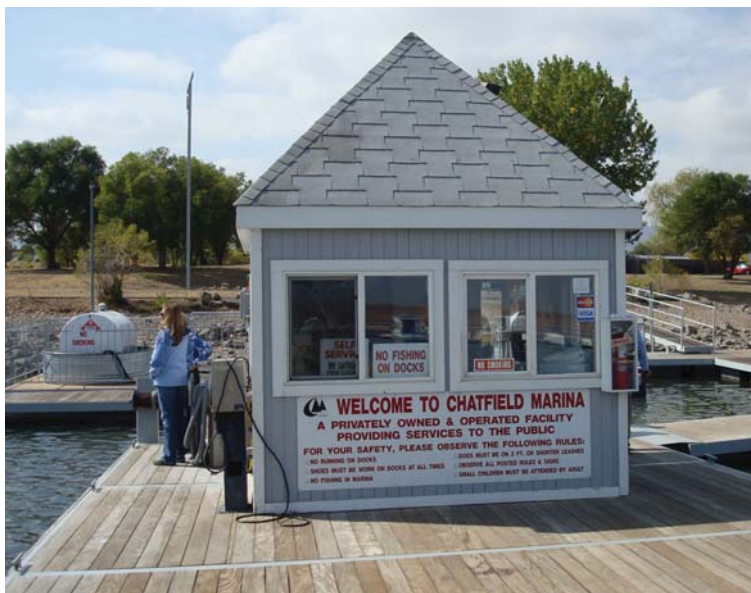
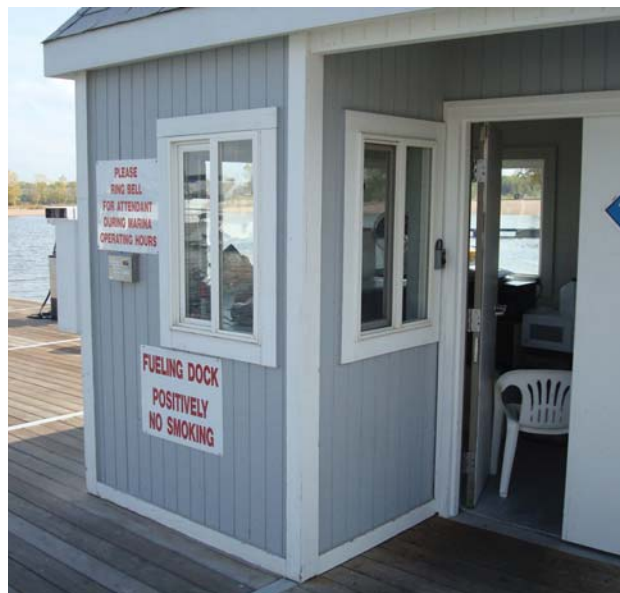
3-8 Fuel Hut

The marina has a 2,000 gallon gasoline only capacity for marine fueling. This is provided by four 500 gallon above ground storage tanks (AST) each within galvanized steel containment tanks floating on dock platforms. Filling of the tanks is accomplished by the tanker man dragging the fill line down the gangway and manually filling each tank separately. The tanks are connected and they feed the two fuel dispensers on the fuel dock. There is no diesel fuel available.

A replacement for the existing floating platform based office, convenience store, and restaurant is recommended. The fuel system should be modified to provide USTs above the 50 year flood level. This would simplify the tank fill procedure and would increase safety for the facility. Replacing the fuel system with a system similar to existing was discarded since, the distance from the new roads to any dock mounted AST would be impractical in either of the proposed alternatives.

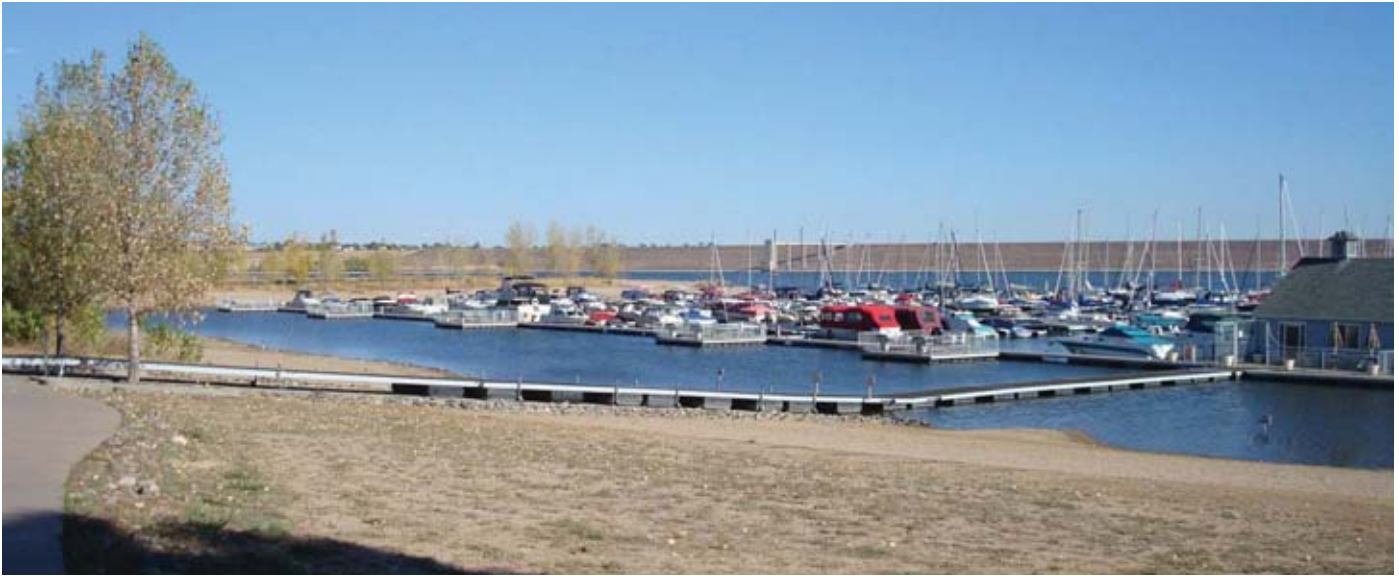
3-13 Main Gangway to Marina

The primary access to the floating marina is by a 150' long articulated floating walkway that rests on a concrete accessway during low water conditions. The gangway functions until the water elevation reaches 5440'. No security gates are provided on the gangway, but access is through a gate located on the floating restaurant platform.

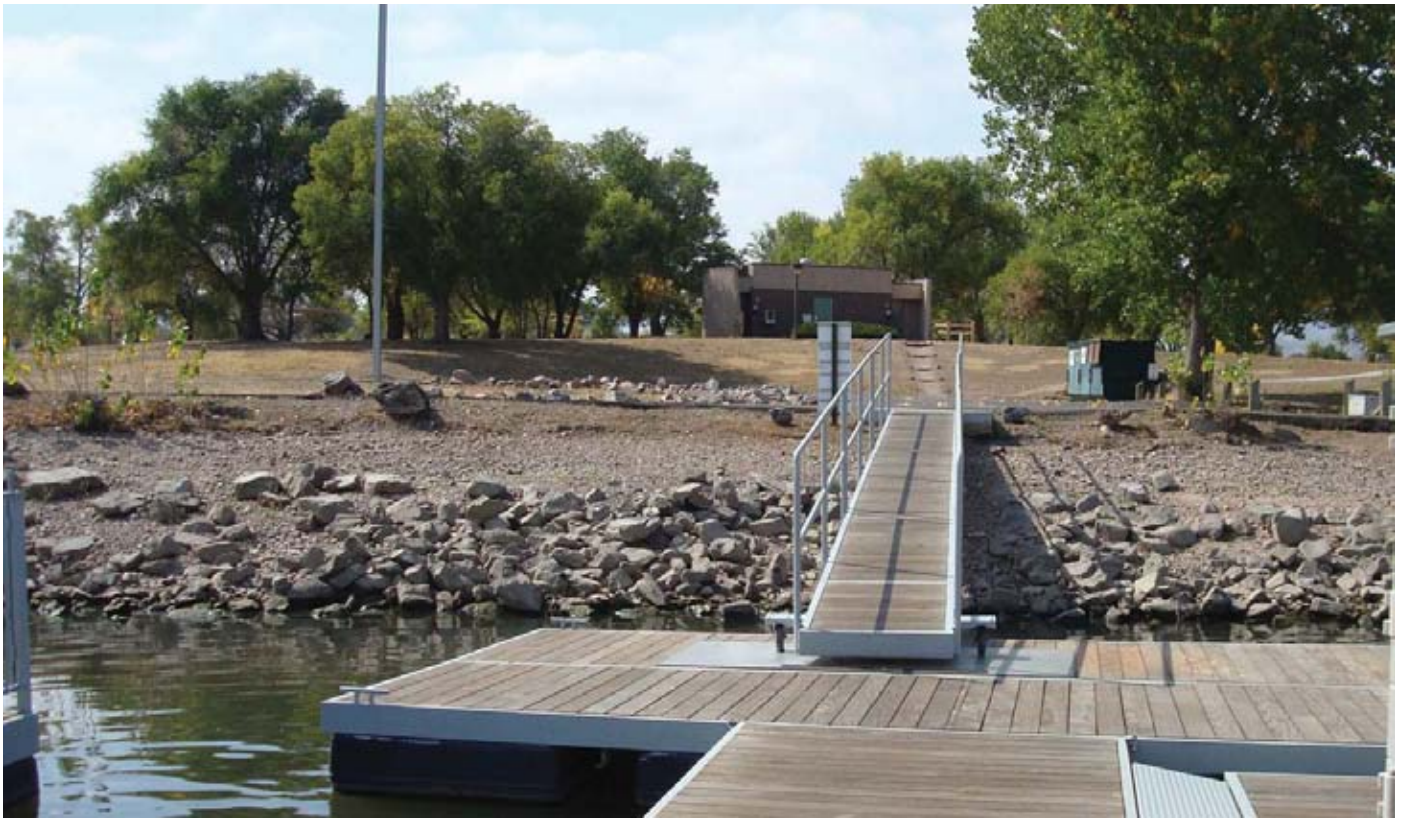
3-15 Fuel Dock Gangway

A secondary access to the docks is located at the fuel dock. This gangway provides restroom, trash receptacle and parking lot access to the boaters and allows the tanker man a means of access during the fueling evolution. The gangway is relatively short and may become uncomfortably steep during low water conditions.

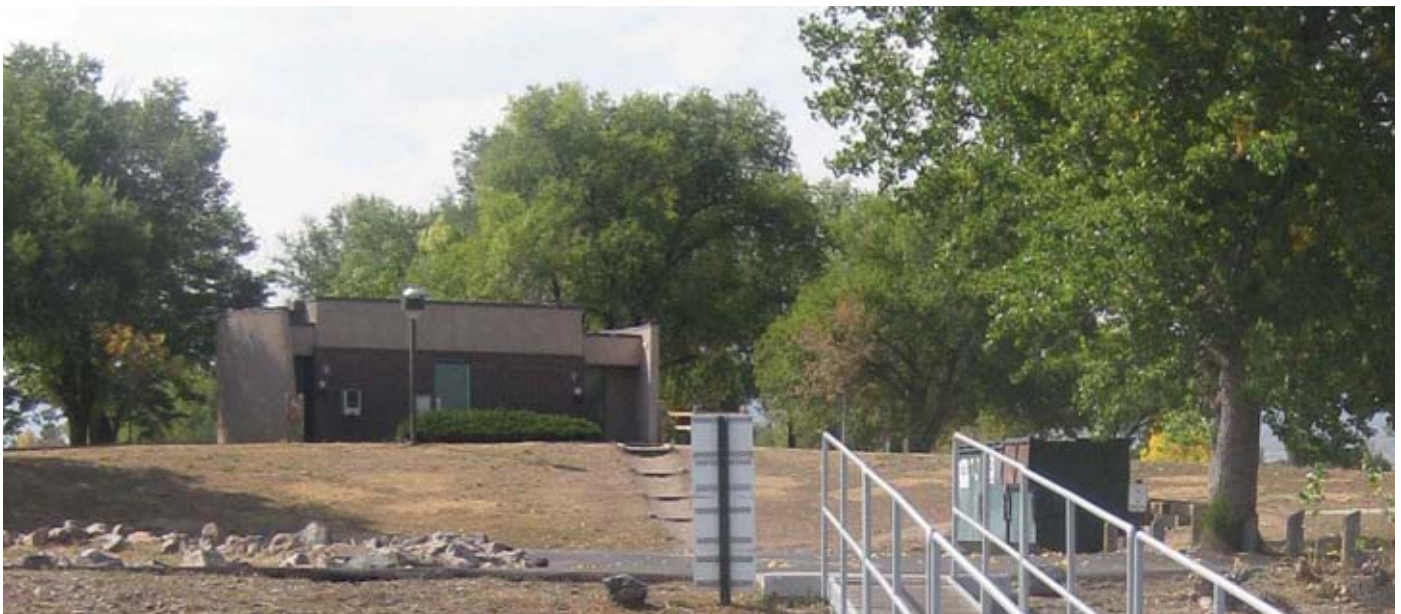
3-16 Upland Restrooms

No upland restrooms are directly maintained by the marina operator. There are two state park restroom facilities near the marina parking areas, one to the south and another just east of the parking lots. Both are plumbed and connected to the sanitary system. Both restrooms are situated below the proposed 5,444' inundation line.

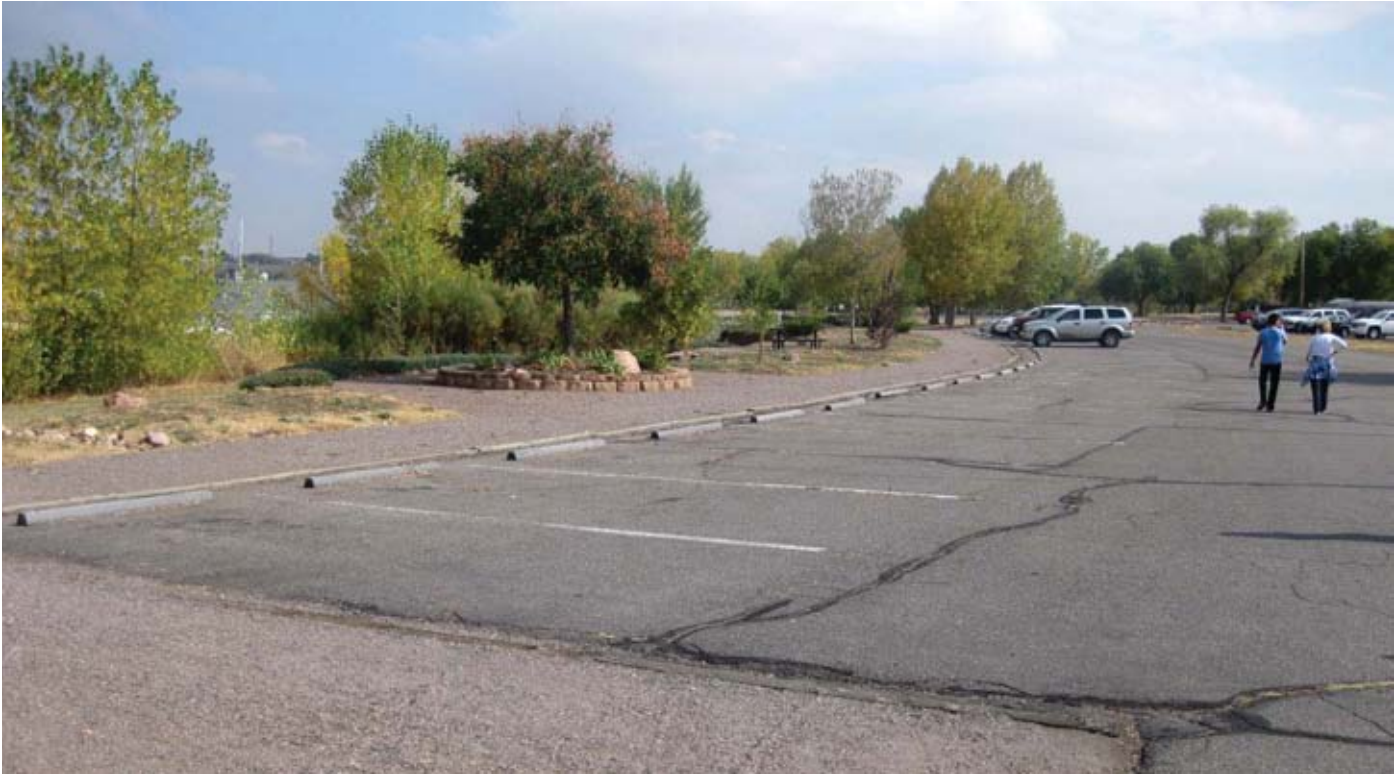
3-17 Existing Parking Lot

The marina facility is serviced by a 258 stall parking lot supplemented by a launch ramp parking facility with 65 trailer spaces and 62 car spaces. Both lots are contained within the bounds of the 5444'elevation affected zone. The lots are in fair condition.

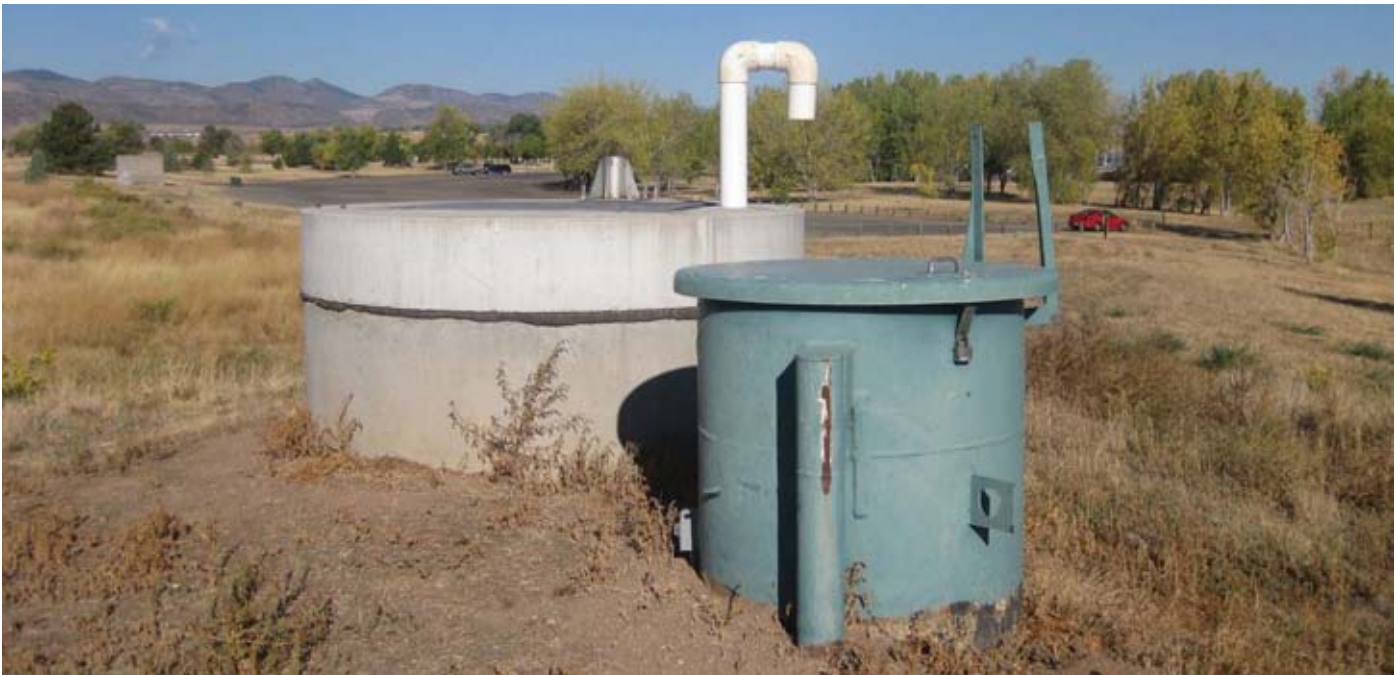
3-20 Lift Station 2

Marina waste is discharged via a lift station (FM1) from the restaurant building to the upland lift station approximately 1,700'; a second lift station (FM2) discharges the waste off site and into the municipal system another 4,700'. FM2 is located at 5,447' MSL and will be inundated during flood events.

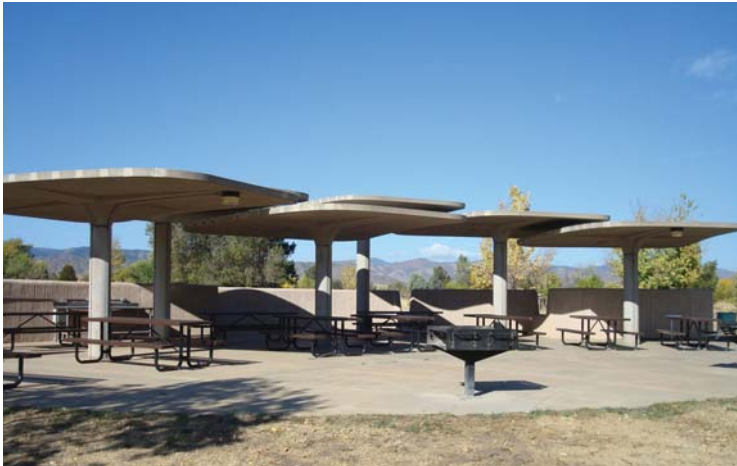
3-21 Picnic Shelter

Multiple shelters are located near the marina and seem to be well used. Previous flood events have caused catastrophic failures at some of the structures.

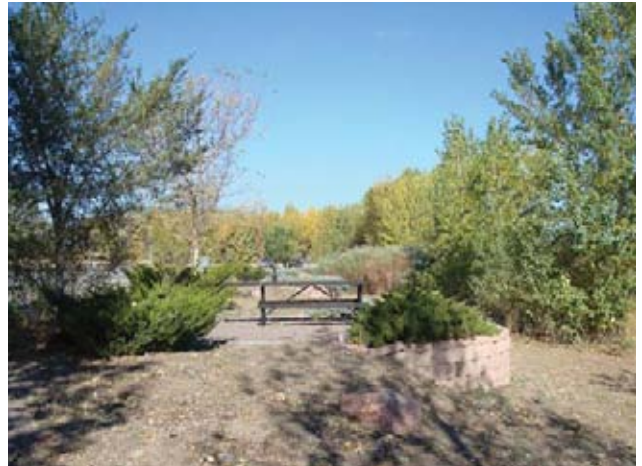
3-22 Picnic Table

Much of the park furnishings are dated and in only fair condition.
